# BRUSH VALLEY DAM

NDI-PA 00652  
PA DER 19-3

## PHASE I INSPECTION REPORT NATIONAL DAM INSPECTION PROGRAM

JULY 1979

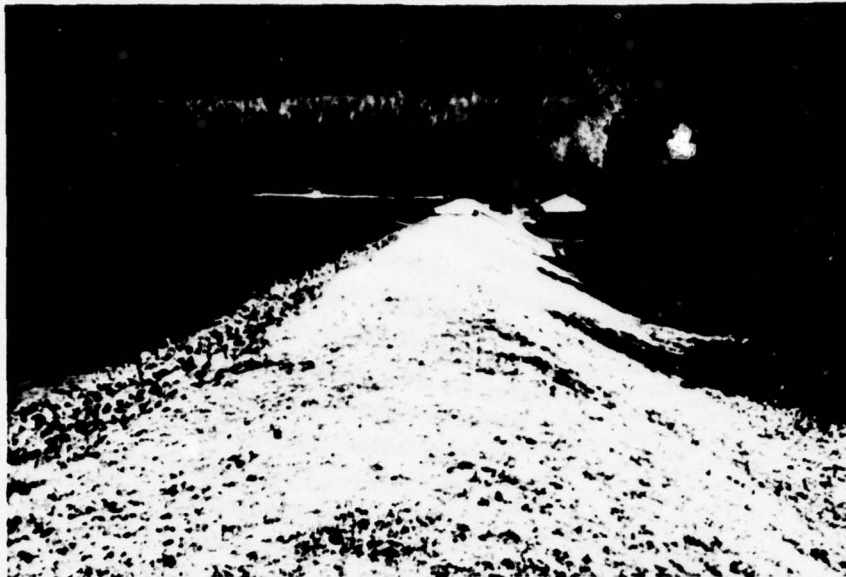
The downstream slope has a number of bulges between the spillway and the pumphouse. The downstream portion of the embankment is noticeably non-uniform in slope along this portion of the dam. The bulges may be due to poor construction control or methods; no indications of recent movement or cracks are evident. Some minor sloughing and erosion of the embankment toe was noted to the left of the pumphouse.

*EMBANKMENT AND PUMPHOUSE  
LOOKING SOUTH FROM THE RIGHT ABUTMENT*

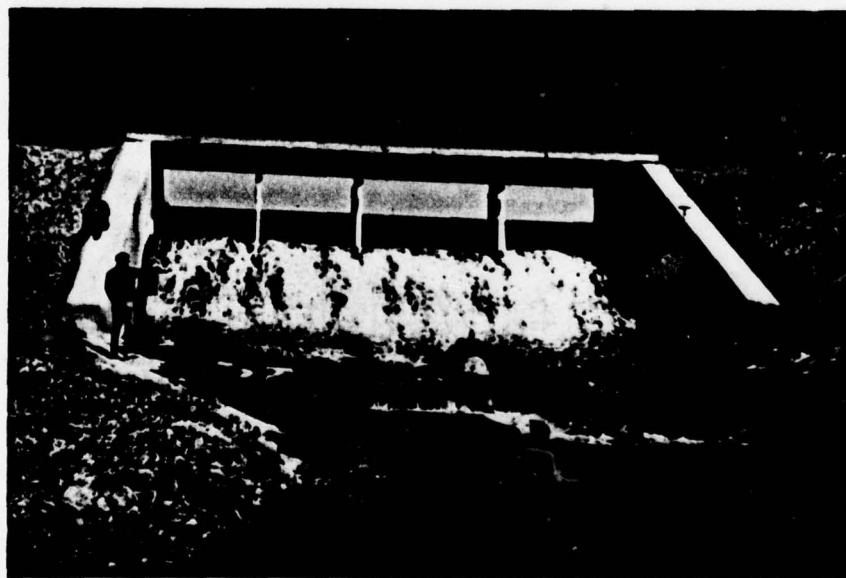
*DOWNSTREAM VIEW OF THE SPILLWAY WITH  
THE DIVERSION PIPE CONTROL VALVE IN THE FOREGROUND*

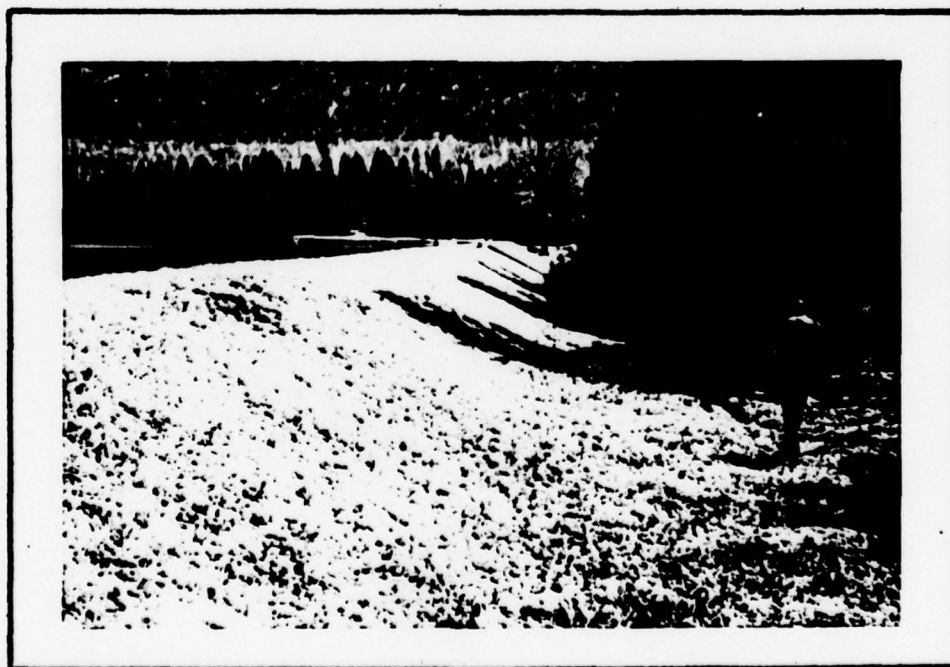
Areas of saturated soil and small puddles of water were located along the toe of the embankment between the pumphouse and the spillway below the general area of the embankment bulging. The wet soil condition extends about one third up the length of the slope. No movement could be detected in the puddles of water; the water appeared to be clear. The downstream slope is covered in dense grass that appears to be well maintained. Two small pine seedling were located along the embankment slope. A number of large pine trees, 16-18 inches in diameter, are located about 10 feet downstream of the embankment toe on the right side of the spillway section.

*DOWNSTREAM SLOPE OF THE EMBANKMENT*

3. Provisions for placing an additional positive control valve on the 16-inch diversion pipe upstream of the embankment should be made. The valve operating mechanism should be fully accessible for all flow conditions.
4. A ditch should be constructed to drain water away from the toe of the embankment.

Further investigation should be initiated to determine the cause and severity of the moisture condition.

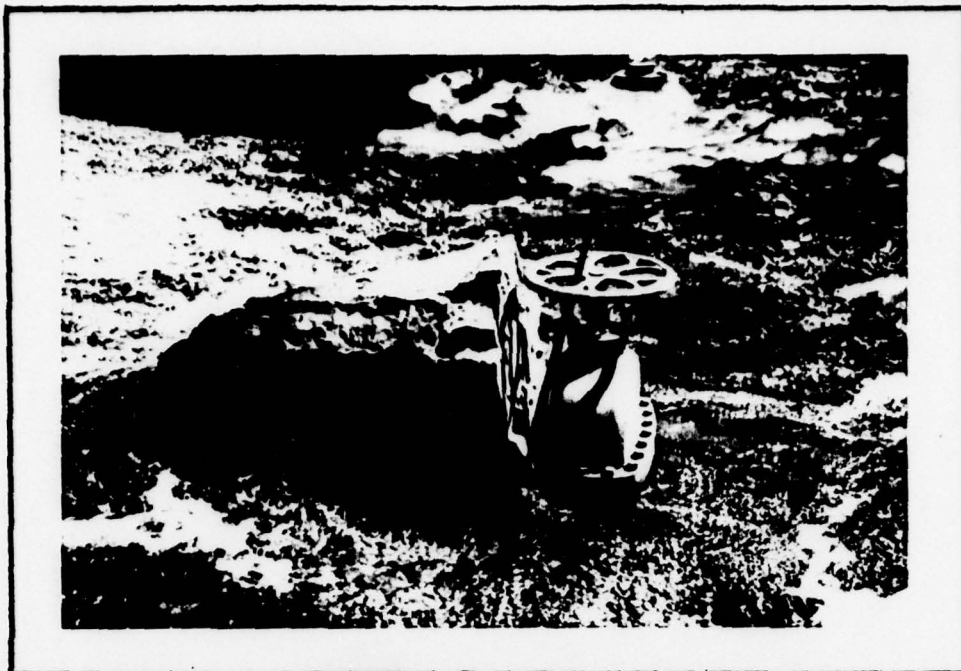
The single control valve on the diversion pipe located in the center of the spillway discharge channel, is considered inadequate. The valve control wheel would not be accessible under all flow conditions. An additional valve should be located upstream of the existing valve and should be readily accessible to operating personnel during all weather conditions.

The operational control of the diversion pipe is considered to be inadequate. The control valve would not be accessible under all flow conditions.

*DIVERSION PIPE CONTROL VALVE IN THE OUTLET CHANNEL  
IMMEDIATELY DOWNSTREAM OF THE SPILLWAY*
